MARTECH

Issue Date Autumn 2009

Assessment and Inspection of Buildings and other Facilities: See inside for more...

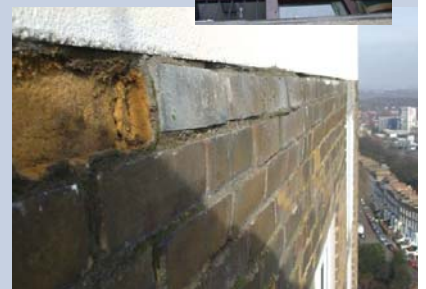
Using abseil access **Martech** engineers surveyed the various elevations of the blocks and found areas of concrete carbonation with the inevitable reinforcement corrosion, these areas were logged for the report. The brickwork had areas of debonded or loose slip bricks at the floor levels and lintols.

Martech removed the loose material for safety reasons and assembled all the data and test results that combined into a comprehensive electronic condition report submitted to the consulting engineers for their interpretation and recommendations to their client.

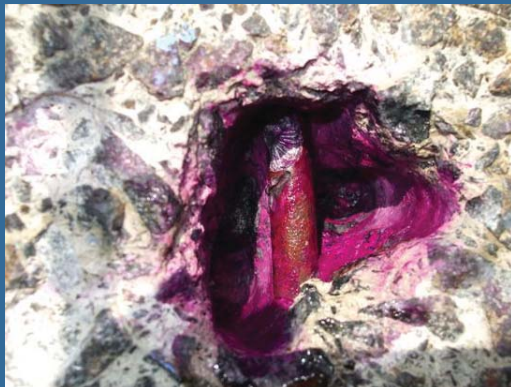
Martech engineers abseiled the external elevations and found the reinforced concrete to be suffering from advancing carbonation exacerbated by low concrete cover in some places. This combination has caused steel reinforcement corrosion and areas of spalling concrete. Previous old repairs were also found to be defective and failing.

The **Martech** report submitted to the consulting engineers on completion of the survey contained extensive details of the problem together with repair recommendations including the use of corrosion inhibitors and anti-carbonation coatings.

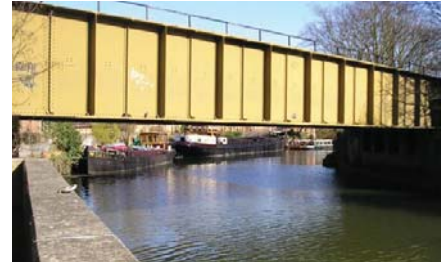
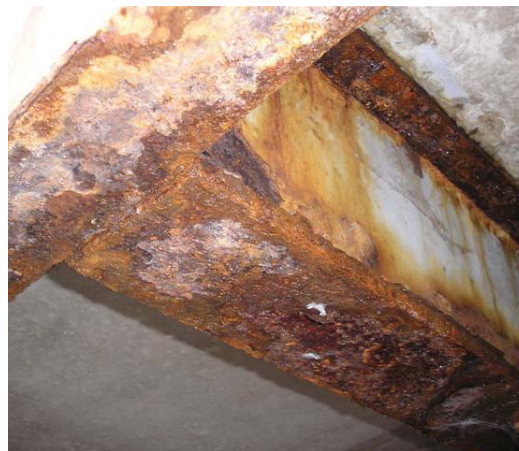
Industrial rope access methods were adopted by **Martech** for the inspection work. The bridge steelwork was found to be suffering from corrosion to varying degrees depending on the location and condition of the existing coatings and was recommended to be grit blasted and recoated. Bridge bearings have long ceased functioning due to heavy corrosion and require cleaning and protection.

The brick abutments and wingwalls surveyed by **Martech** need localised repairs to cracks, spalls removal of vegetation etc. A full photographic record was made of the bridge making particular reference to the inspection findings.

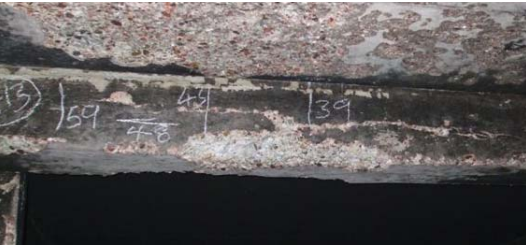
Martech engineers have many years experience in this field and can recognise the tell tale signs of fire damaged concrete. A visual inspection together with non-destructive testing and exploratory cutting out of the fire damaged areas enable **Martech** to advise the client in a detailed report about the schedule of damage and suitable repair solutions.
