# The Inspector

Inspection and Testing News from Martech

Spring/Summer 2015

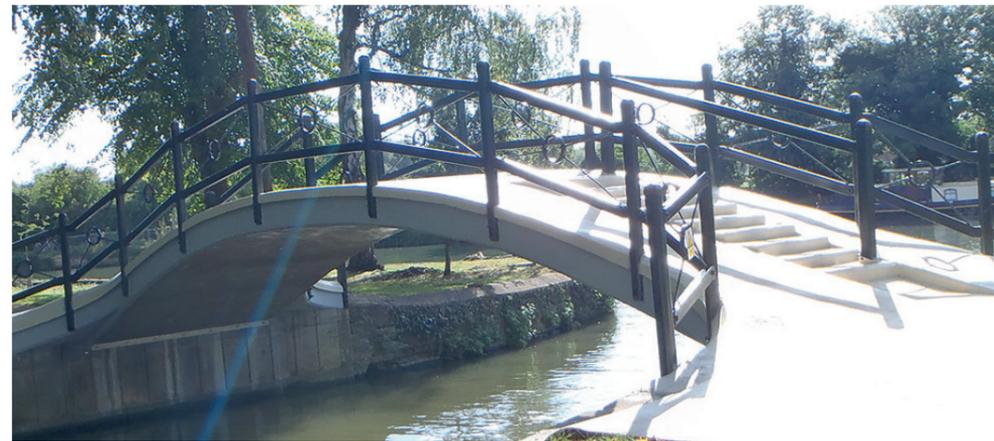
The problem was severe, unrepairable corrosion of the post tensioning in the structure. This had resulted in the complete loss of all tensioning wires through corrosion in several places, and extensive decay elsewhere. The structure was originally built from a series of interlinked, tapered precast

concrete sections (rectangular inverted boxes), stabilised by post tensioning into the arch form, with a reinforced concrete topping over.

The innovative repair solution arrived at by Martech Technical Services, working in conjunction with the structural consultants, employed corrosion mitigation techniques including Margel corrosion inhibitor. These were applied both on the redundant post tensioning strands and on the cage around these. Following concrete repairs to the original, the formation of a strong yet slender reinforced concrete arch structure under the bridge stabilised the precast segments and acted as new structural concrete. The voids in the sections were filled with polystyrene, leaving small inverted voids for the new slab to key, thus adding directional stability to the existing main structure.

The completed and newly waterproofed structure looks fresh and retains its original slender profile through careful sympathetic and innovative concrete repair design solutions.

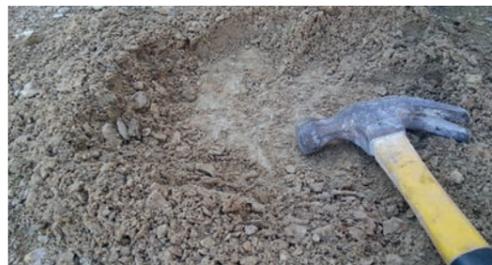
Martech has undertaken concrete investigations on a concrete slab in the liquid oxygen delivery area of a well-known English city hospital. The investigations showed extensive concrete failure on the tanker delivery slab adjacent to oxygen storage tanks, as well as the tank base itself.

It was clear to Martech that they were likely to be dealing with a cryogenic failure mechanism, and their concrete investigation proposals included both in situ examination and exploration, plus cores for laboratory examination - including petrographic analyses. The tanker delivery apron had suffered deep and permanent damage, largely in the form of exaggerated freezing thaw damage that completely disrupted the matrix of the structural slab.

Martech provided remedial advice involving very specialist concrete mixtures, and the urgent remedial works will have to be carefully planned and implemented so as to avoid any disruption to operations in the hospital.

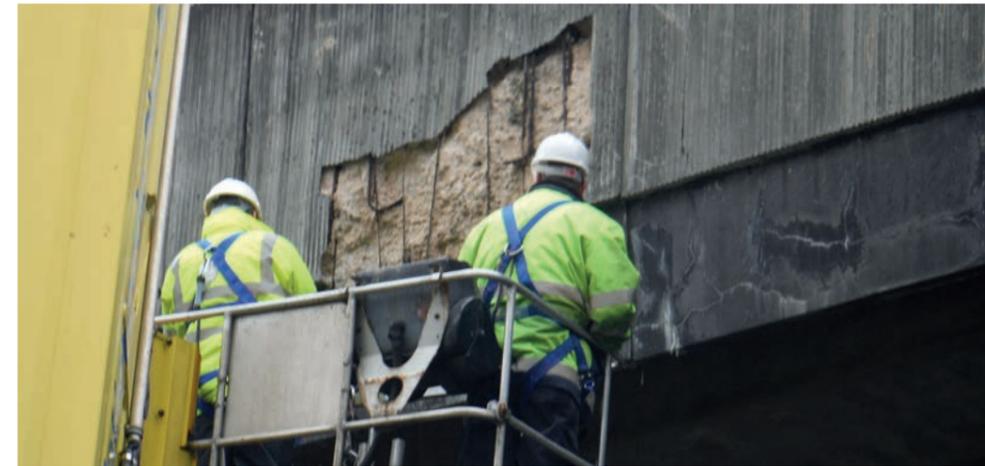
The main concern on this viaduct, spanning two local roads, a river and a railway, was the poor condition of the parapet facing panels. These were of an ill-considered and poorly executed early 1980s design, and had not aged well. Martech also did some concrete condition survey works on the piers and cross heads of the structure, to confirm their visually sound concrete condition.

On-site testing revealed the parapet edge panels to be in such poor condition with danger of falling concrete, that immediate safety works were implemented with a road closure below in order to remove the failed concrete. Martech were at this stage asked to extend their involvement by providing an outline design for the replacement of the edge beam detailing.

Once the refurbishment and concrete repair works had been tendered, Martech were also retained as the client's concrete repair consultant, making weekly visits throughout the duration of the works by the selected concrete repair contractor.
