## Fire Damaged Concrete

Issue Date Autumn 2011

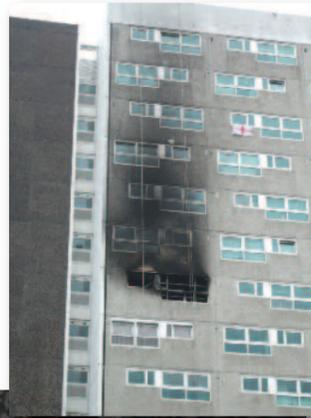
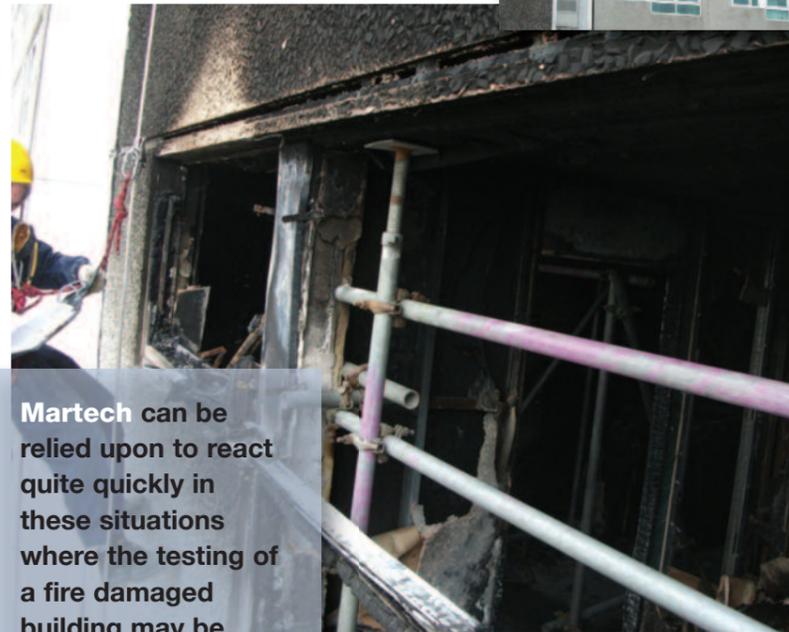
**Martech** engineers abseiled the external elevations and found no severe signs of distress to the panels although there was some very localised pinking of the concrete, classic signs of heat affected concrete, and soot build up on the elevations. These observations together with test data and measurements were reported back to the client for their structural engineers to assess and design a repair specification.

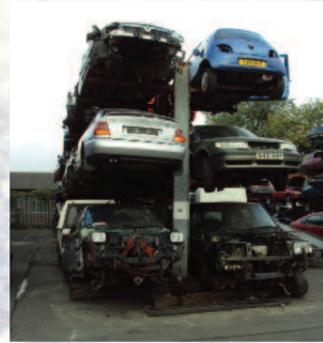
**Martech** were recently requested to carry out a concrete condition survey to a concrete slab at a motor salvage yard where a vehicle fire had possibly damaged the concrete.

Cores were taken to determine the concrete make up and strength from the areas of fire damage and adjacent non effected areas as a control and tested in a laboratory.

**Martech** engineers also inspected the sub base construction in the areas of greatest damage putting all the information, photographs and test results together with repair recommendations in a detailed report to the consultant structural engineers.

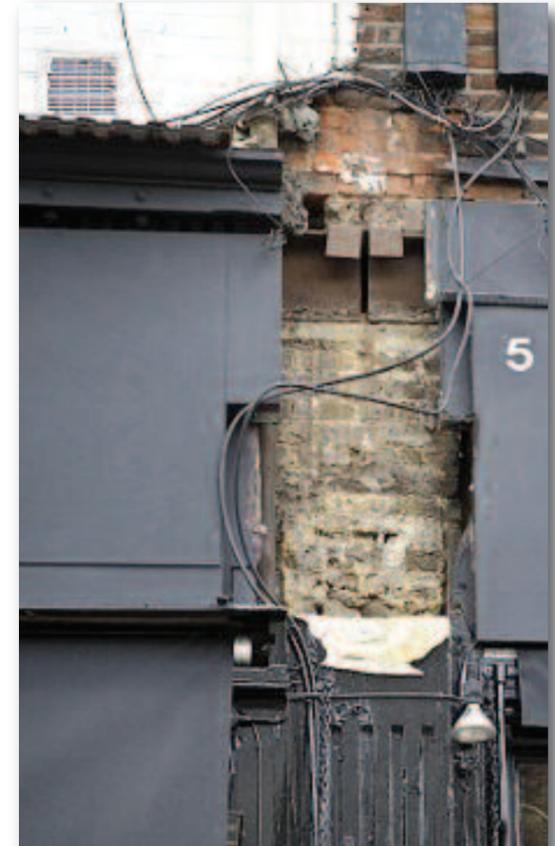
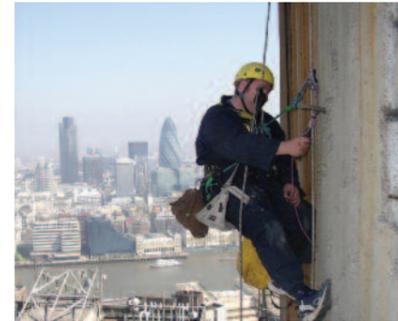
An horrific accident recently occurred in London when a very substantial lump of masonry fell from the façade of a building, onto part of a busy restaurant below, hitting a customer on the head with fatal consequences.

This type of incident is thankfully very rare but nevertheless highlights the danger that old buildings can present if not properly and regularly inspected. This accident is the subject of an inquiry, so no blame has as yet been apportioned, **but the local council has urged business owners to check that their structures are safe.**

**Martech** engineers carry out many making safe inspections and specialise in removing loose material from buildings, including containing large unstable areas of facades with mesh to prevent pieces falling as an interim measure.

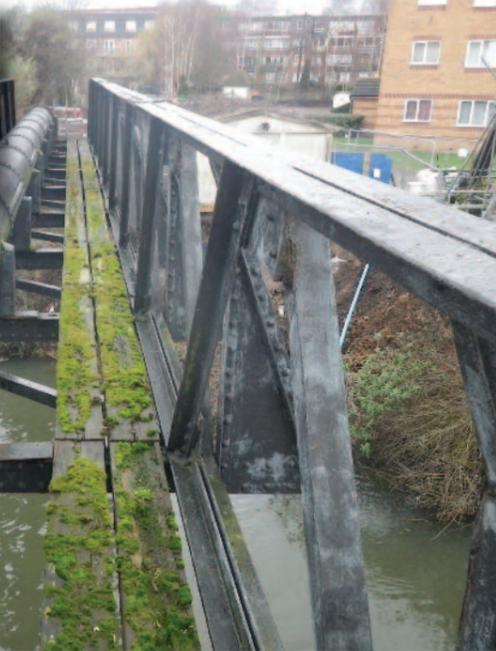
Such a steel pipe bridge was needing to be replaced that spanned the River Lea in north London but before the old bridge could be lifted out of place the structural engineers in charge had to know the condition of the structure to assess its integrity for safe lifting.

**Martech** engineers carried out a thorough inspection along the full length of the steel bridge visually inspecting and recording defects and hammer tapping all connection bolts and rivets.

The results of the inspection were stated back to the client in a detailed report highlighting areas of possible concern that may affect the lifting process.

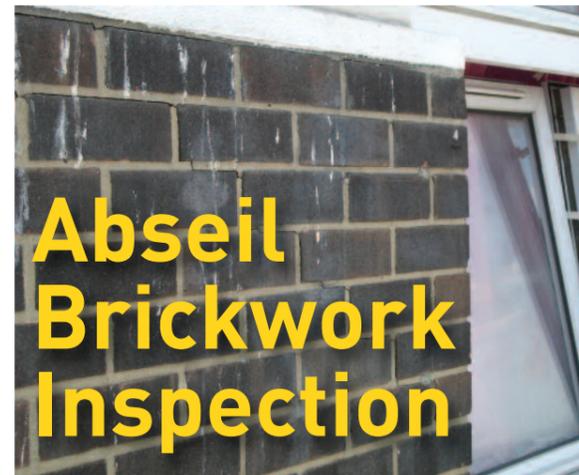
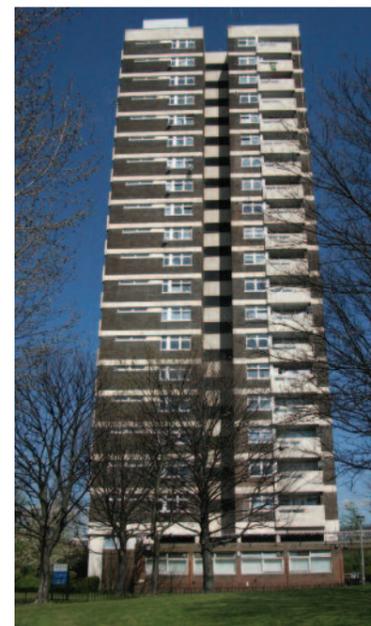
The tower block is of reinforced concrete frame construction with brick infill panels originally built over forty years ago and undergone several refurbishment programmes including replacement windows etc.

**Martech** engineers accessed all of the external facades to inspect the brickwork, locate wall ties and calculate their density and inspect their condition by borescope and record a log of all visible defects onto drawings. Photographs were also taken to record these defects including other defects to windows, concrete and joints etc. The brickwork panels were also measured with basic dimensions of the panels put onto drawings for estimation of quantities for remedial work.

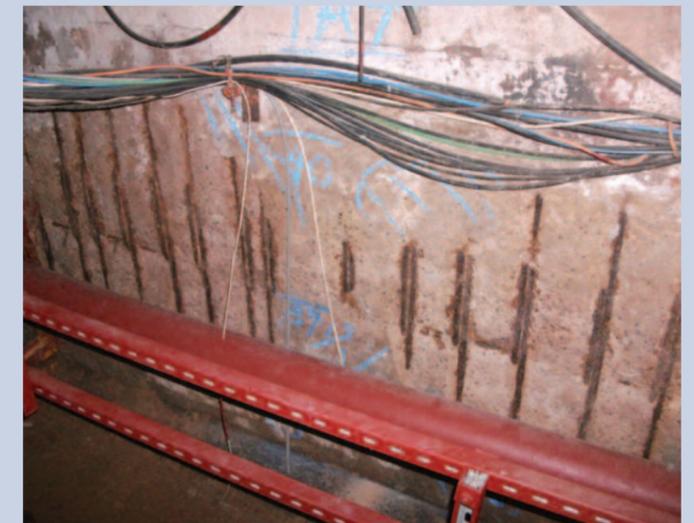
The structure was found to be suffering from carbonation of the concrete (a natural ageing process) and showing signs of water ingress from above. Chloride levels were mainly within acceptable limits, with locally high levels from road salt ingress.

**Martech** submitted a detailed report to the consulting engineers with a concrete repair and waterproofing recommendation involving steel reinforcement corrosion inhibitors, galvanic anodes and a protective coating system to the exposed concrete surfaces.
