The Inspector

Inspection and Testing News from Martech

Spring 2019

COLD WAR CORROSION

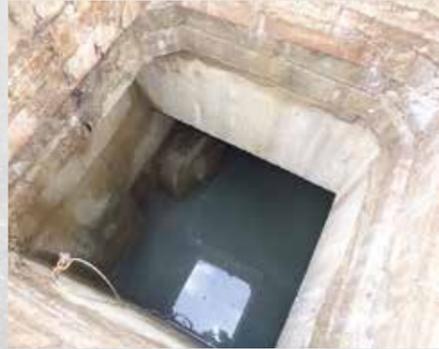
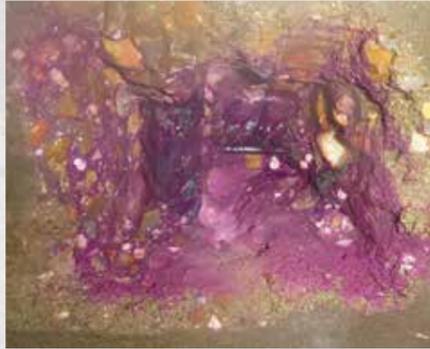
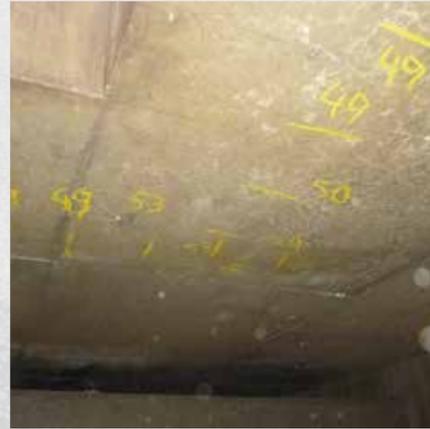
Martech was engaged by a firm of consulting engineers for whom we frequently act as sub-consultants, in order to assess the reinforcement on a drainage chamber slab that was to be incorporated into a road on a new development. There was some question over the exact reinforcement that had been incorporated within what was a one-off variation on the standard design.

Martech attended site with a three-man confined space trained team in order to access the chamber and carry out the necessary investigation works. It was required to state bar types, covers and spacings for the Structural Engineer retained by the house builder developing the estate.

The works were reported upon in a brief letter report with photos and survey sheets to enable the engineer to do his design checks.

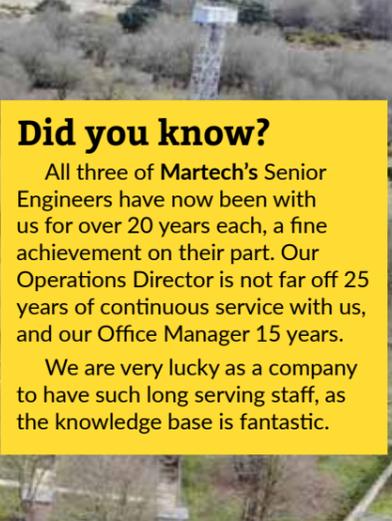
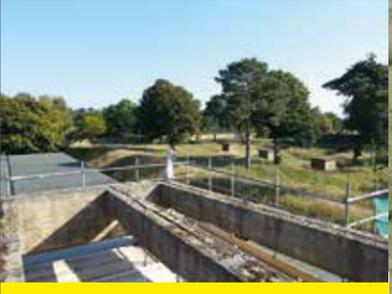
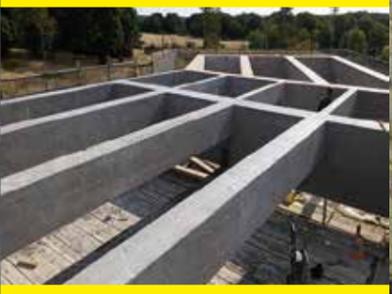
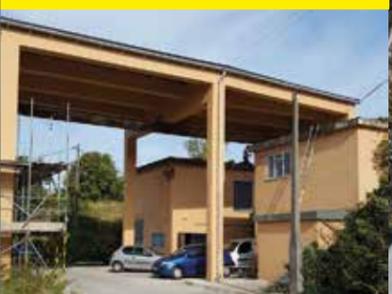
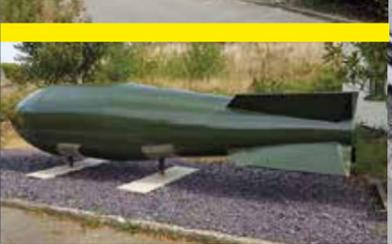
The main structures were suffering hugely from reinforcement corrosion, both carbonation and chloride induced, with the proprietary system concrete repairs being enhanced by the blanket use of Margel corrosion inhibitors and elastic anticarbonation coatings. Historic England has been heavily involved in the restoration process working with the owner, the architect and Martech. The choice of finishes was designed to preserve the board finishes and original operational appearance and colours of the buildings but with significantly enhanced – and sorely needed – additional reinforced concrete protection to ensure preservation of the structures for future generations.

Martech has been involved in an advisory capacity with the owners and their consultants over many years, by way of concrete condition surveys, concrete repair advice and assistance with the development and execution of a concrete repair process designed to restore as well as preserve the main reinforced concrete structures.

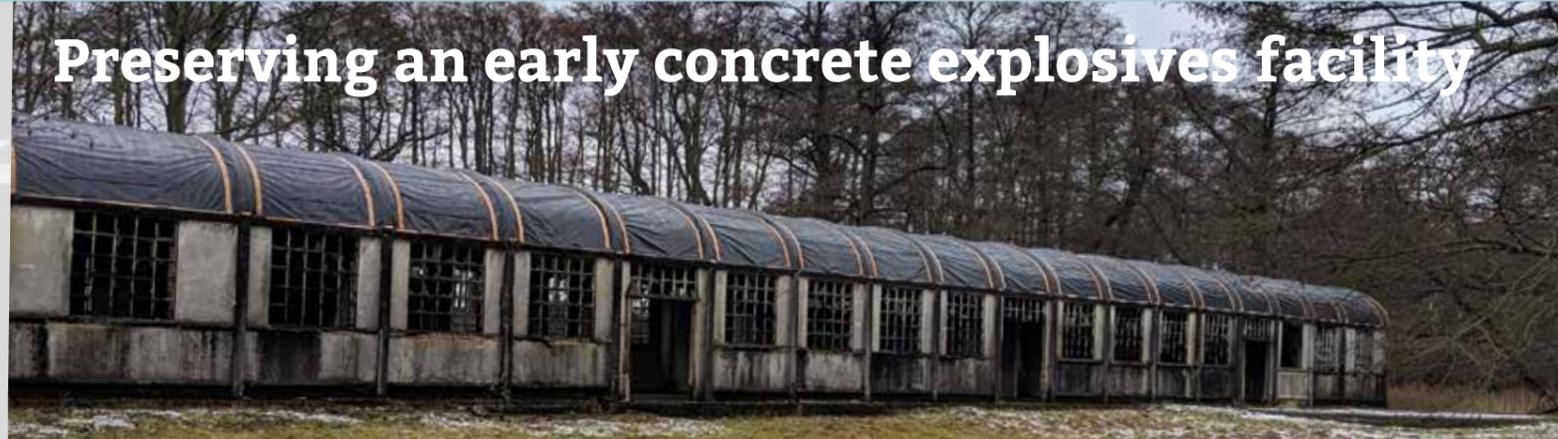
Martech initially carried out a detailed condition assessment of the heavily-corroded fabric to enable pragmatic repair advice for the structure (built 1935-37), in additional discussion with Historic England. The concrete and condition assessment was reported to our usual high standards with the later requirements for further works tendered.

This is a steel-framed structure with the frame wrapped on EML and rendered over. A lightweight RC roof and wall panels formed with decorative render on Hy-Rib sheet feature. In the event of an accidental explosion at this purpose-built cordite drying facility, the front walls and roof would be blown outwards to save the rest of the building.

The trial repairs focused on a single bay and involved new render plus decorative render finishes (as required), over replacement steel frame members with corrosion-resistant finishes. A lot of care was taken to try and produce a similar decorative facing mix. After a number of samples were tried, the final choice was a crushed grey granite and white cement mix, marginally tinted with OPC in order to match the existing weathered finishes.

The bay was finished with gentle power cleaning (deliberately intended to leave some industrial patina), application of corrosion inhibitors, and finally by clear decorative protective coatings.

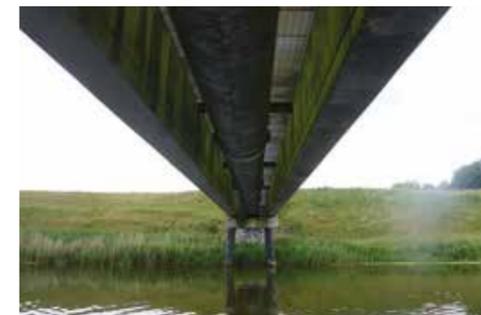
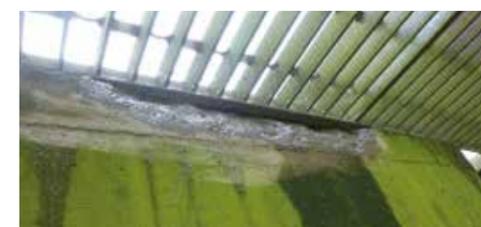
Martech had originally carried out a detailed concrete condition survey on an East Anglian Fens pipe bridge based upon a concrete load carrying structure. The survey had identified a number of concrete repairs to be carried out. The main contractor (MC) appointed by the client for the refurbishment works on the structure re-engaged Martech to draw upon the in-house abseil access expertise, enabling cost-effective access for difficult repairs under direction of the MC.

Martech engineers worked on site for a number of days to assist with the works.
